**SAS Superstructure**

Location: 04-SF-80-13.2 / 13.9

Daily Diary Report by Bid Item

**04-0120F4
04-SF-80-13.2/13.9
Self-Anchored
Suspension Bridge****Weather**

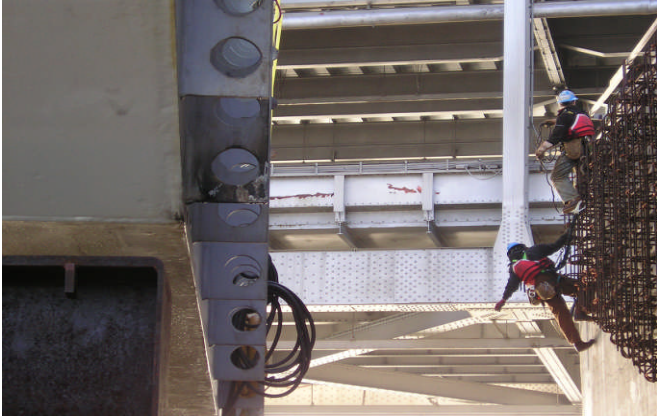
9am, 2 iron workers start to check the rebars at the face of W2 cap beam with the direction of 3 ABF engineers. About 6 workers went inside of OBG L1E to check the alignment of the prestress conduits. Also went with them were 2 surveyers from the contractor.

Workers work on the rebars at the face of W2 cap beam

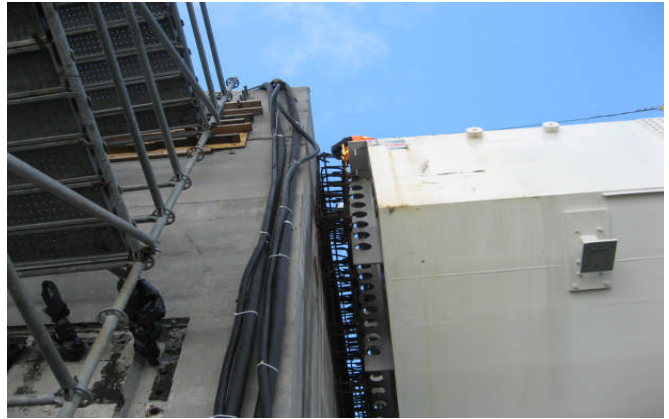
Look from the side of the W2 cap beam for the gap between L1E and W2 cap beam

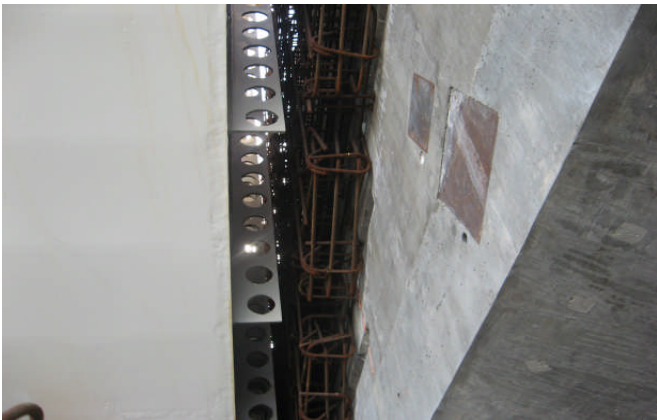
Look from below the W2 cap beam for the gap between L1E and W2 cap beam

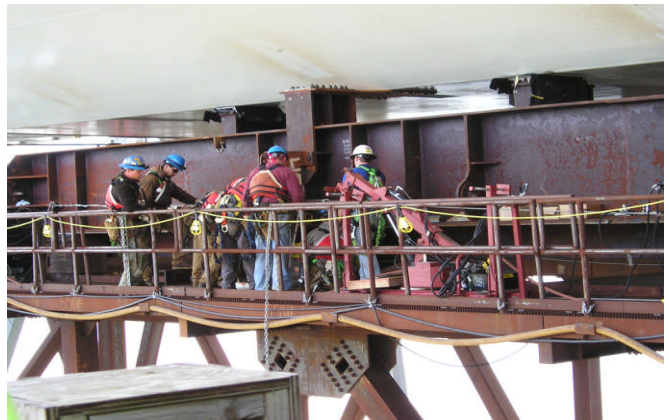
North side seismic prevention shear plates have been installed and all the bolts have been pretensioned.

installation of the seismic stop for L1E

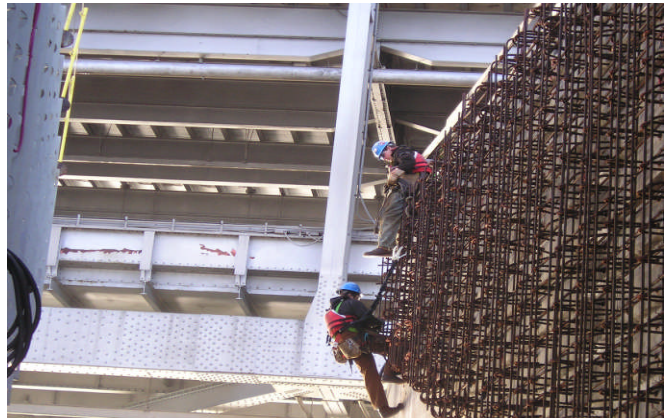
11:15am, 1 iron workers went in between the end face of the OBG L1E and the face of the W2 cap beam to check the potential conflict with prestress conduit, 1 rebar hook is cut.

Workers work on the rebars at the face of W2 cap beam
